# Echo of Prosthetic Valves

Joe M. Moody, Jr, MD

UTHSCSA and STVAHCS

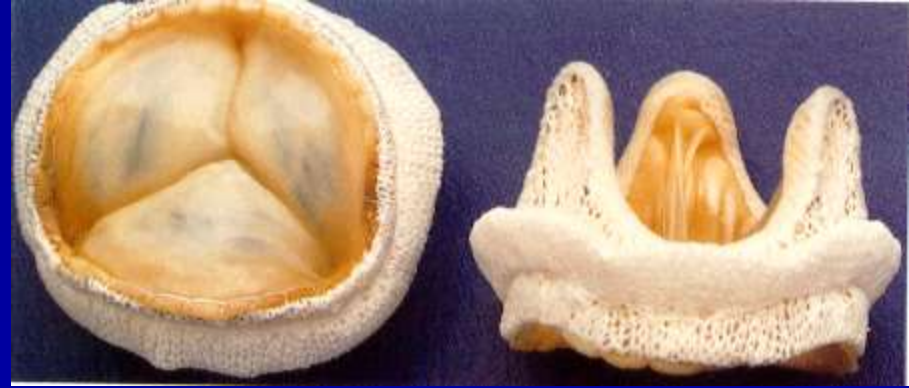
# Biological Prosthetic Valves

- Less thromboembolism, less anticoagulation but less durable and more reoperation
- Options
  - Autograft (pulmonic to aortic .. Ross procedure)
  - Autologous or autogenous pericardial (crafted at surgery)
  - Homograft (allograft – human)
  - Heterograft or xenograft is sterilized and nonviable thus bioprosthesis, bovine pericardial, porcine valve (degeneration is more likely after 5 yr for MVR and after 8 yr for AVR, if regurg is noted, echo q 3-6 mo)

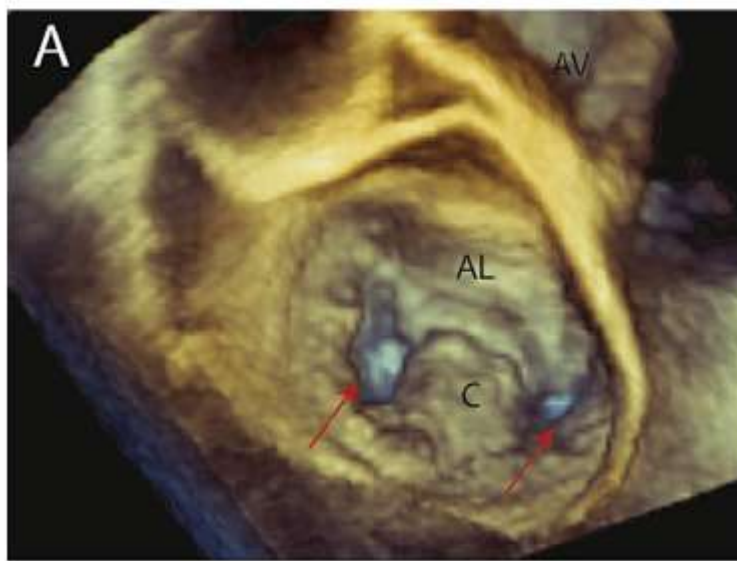
**Figure 11** The unique perspective 3D TEE provides in the visualization of the mitral valve when it has been replaced or repaired surgically or percutaneously. **(A)** Image from a patient with flail mitral valve repaired with the E-valve clip. The *arrows* point to the “double orifice” mitral valve created by the clip (C). **(B)** Image from a patient with a mitral repair with an annuloplasty ring; the *arrows* point to the posterior and anterior aspects of the annuloplasty ring. **(C)** Image from a patient with a stenotic mitral bioprosthesis; the *arrows* point to the suture ring. **(D)** Image from a patient with a bioprosthetic mitral valve and a periprosthetic leak; the *arrows* point to the area of ring dehiscence. AL, Anterior leaflet; AV, aortic valve; LAA, left atrial appendage; RV, right ventricle.

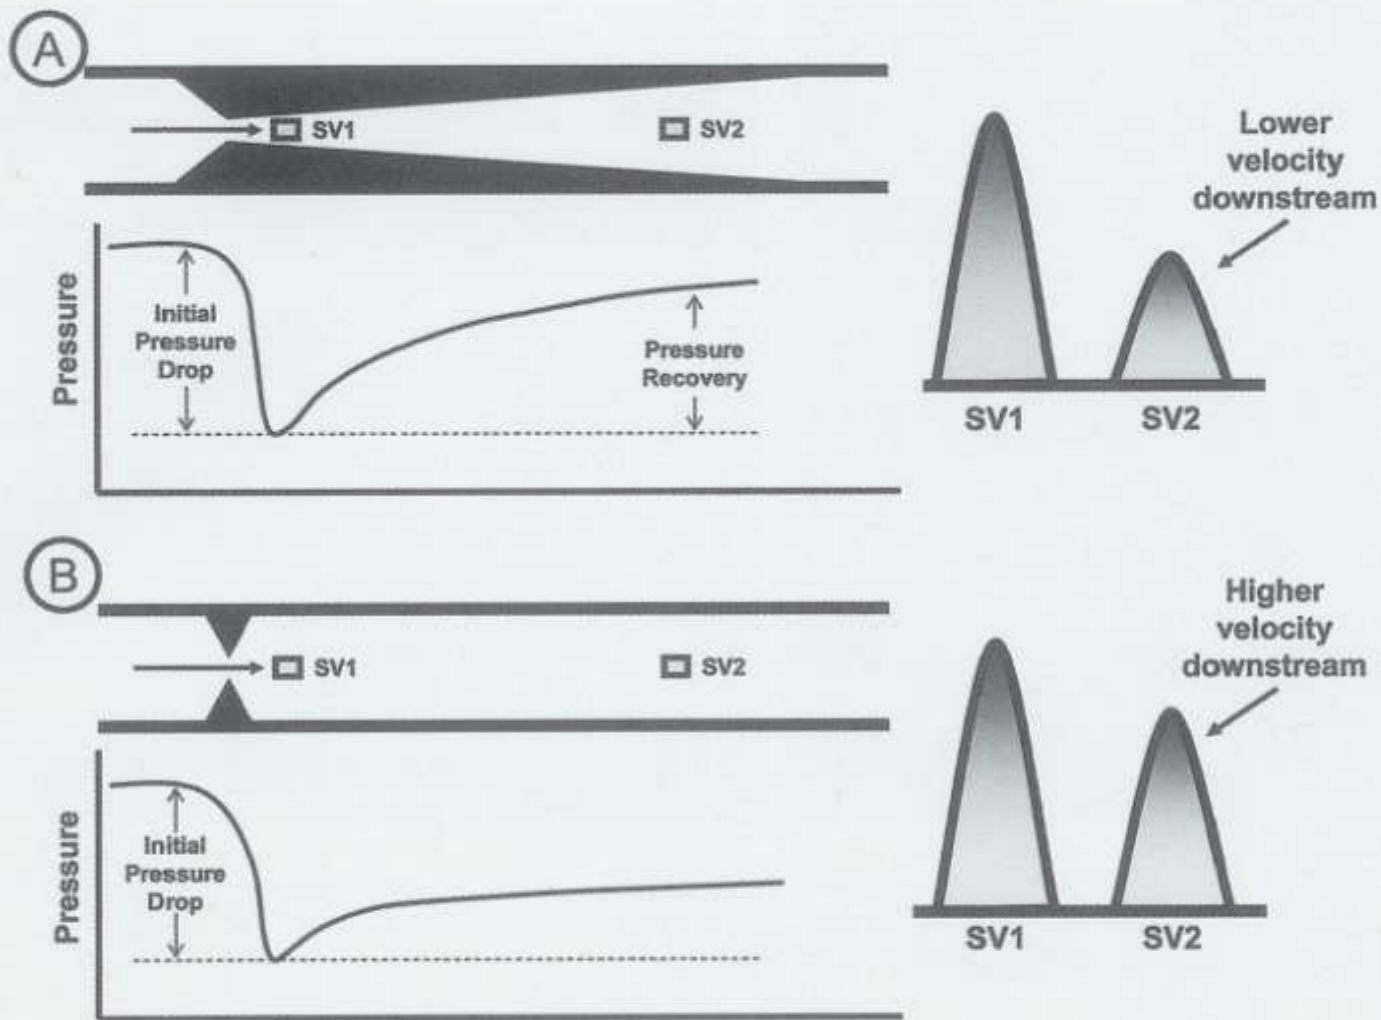
**FIGURE 14.13.** The concept of pressure recovery is illustrated in this schematic. In the top panel, in the absence of pressure recovery, different locations for sample volume (SV) measurement yield fairly similar velocities. In panel B, flow through a tapered stenosis results in significant pressure recovery downstream from the obstruction. In this case, sampling within the obstruction (SV1) yields a higher velocity compared to a sample site downstream (SV2) where pressure recovery has occurred. At this site, the recovery of pressure is associated with a lower velocity. See text for details.

- Bileaflet (St. Jude) mechanical aortic valve may show high velocity (and high localized gradient) through central orifice that is not representative of the more important net gradient (there is pressure recovery)

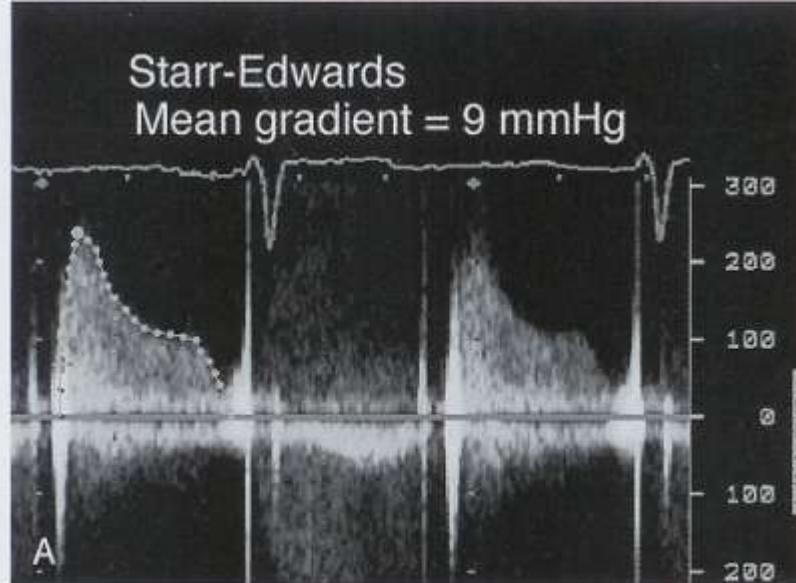
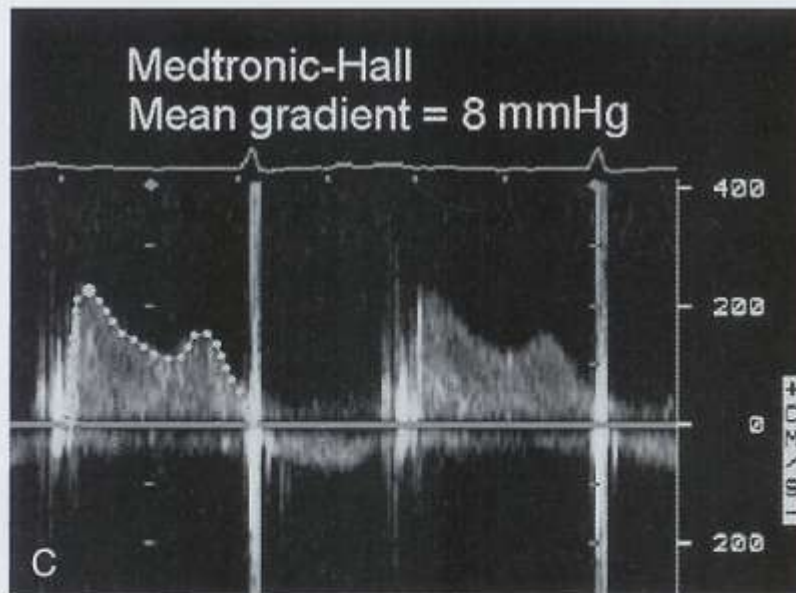
**FIGURE 14.17. A-D:** Doppler recording of flow through four different mitral prosthetic valves is demonstrated. The mean gradient across each prosthesis is indicated.

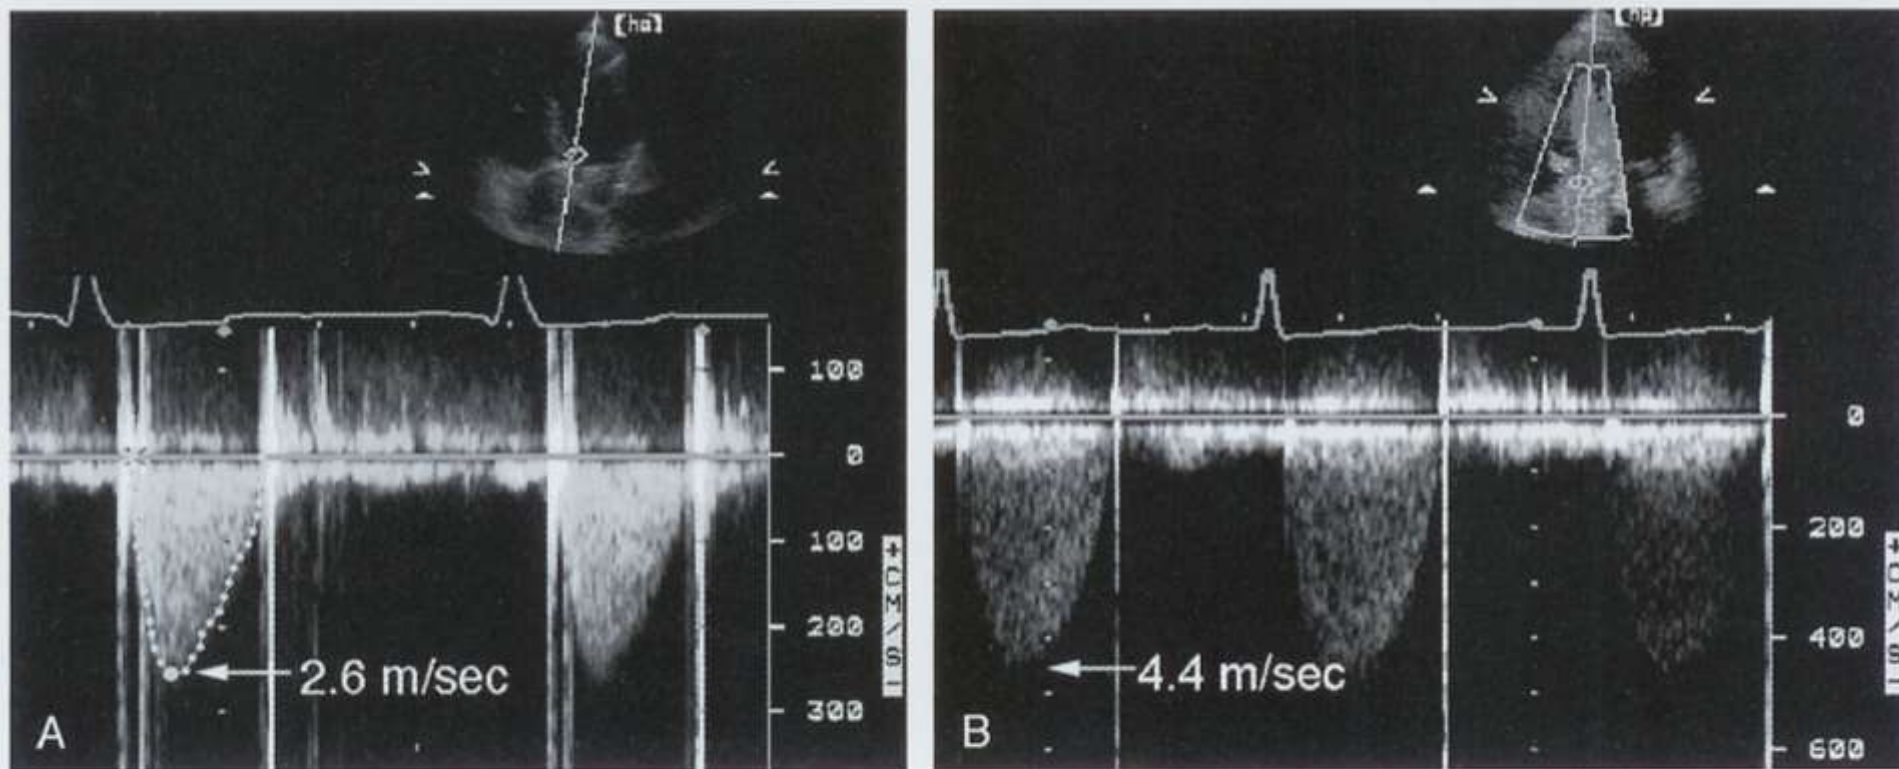
## B: Obstruction shows poor opening click and high velocity

**FIGURE 14.24.** Examples of flow through two different St. Jude aortic prosthetic valves are provided. **A:** Flow velocity is normal and crisp valve clicks are present. **B:** Jet velocity is increased, indicating a peak pressure gradient of approximately 77 mm Hg. Valve clicks, especially at the time of valve opening, are diminished.

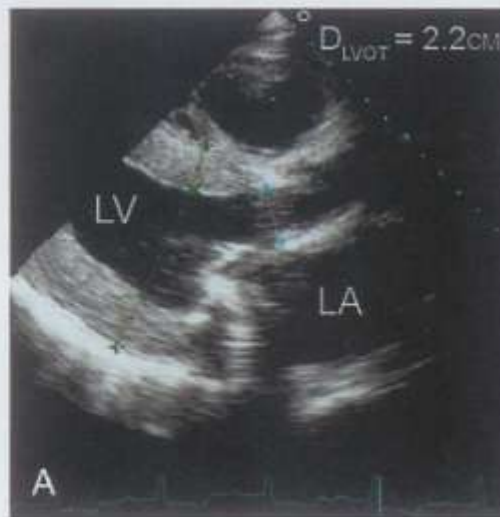
$$CSA_{OT} = .785 \times D^2 = 3.8 \text{ cm}^2$$

$$AVA = \frac{CSA_{OT} \times TVI_{OT}}{TVI_{AV}}$$

$$AVA = \frac{3.8 \times 34}{69} = 1.87 \text{ cm}^2$$

**FIGURE 14.25.** The continuity equation can be used to calculate the effective valve area across prostheses. **A:** The diameter of the left ventricular outflow tract is measured. **B:** Time velocity integral (TVI) of the outflow tract is calculated using planimetry. **C:** Using continuous wave Doppler imaging, flow through the prosthetic valve is recorded. Because of a hyperdynamic left ventricle (LV), the  $TVI_{OT}$  and the maximal pressure gradient are quite high. Despite the maximal gradient of 65 mm Hg, the aortic valve area is approximately 1.9  $\text{cm}^2$ . The calculations used to measure valve area are provided. CSA, cross-sectional area;  $D_{LVOT}$ , outflow tract diameter; LA, left atrium.

- Continuity equation works well in prosthetic valves
- Pressure half-time in MV and TV replacements are useful, but pressure half-time generally overestimates the valve area in MV prosthesis

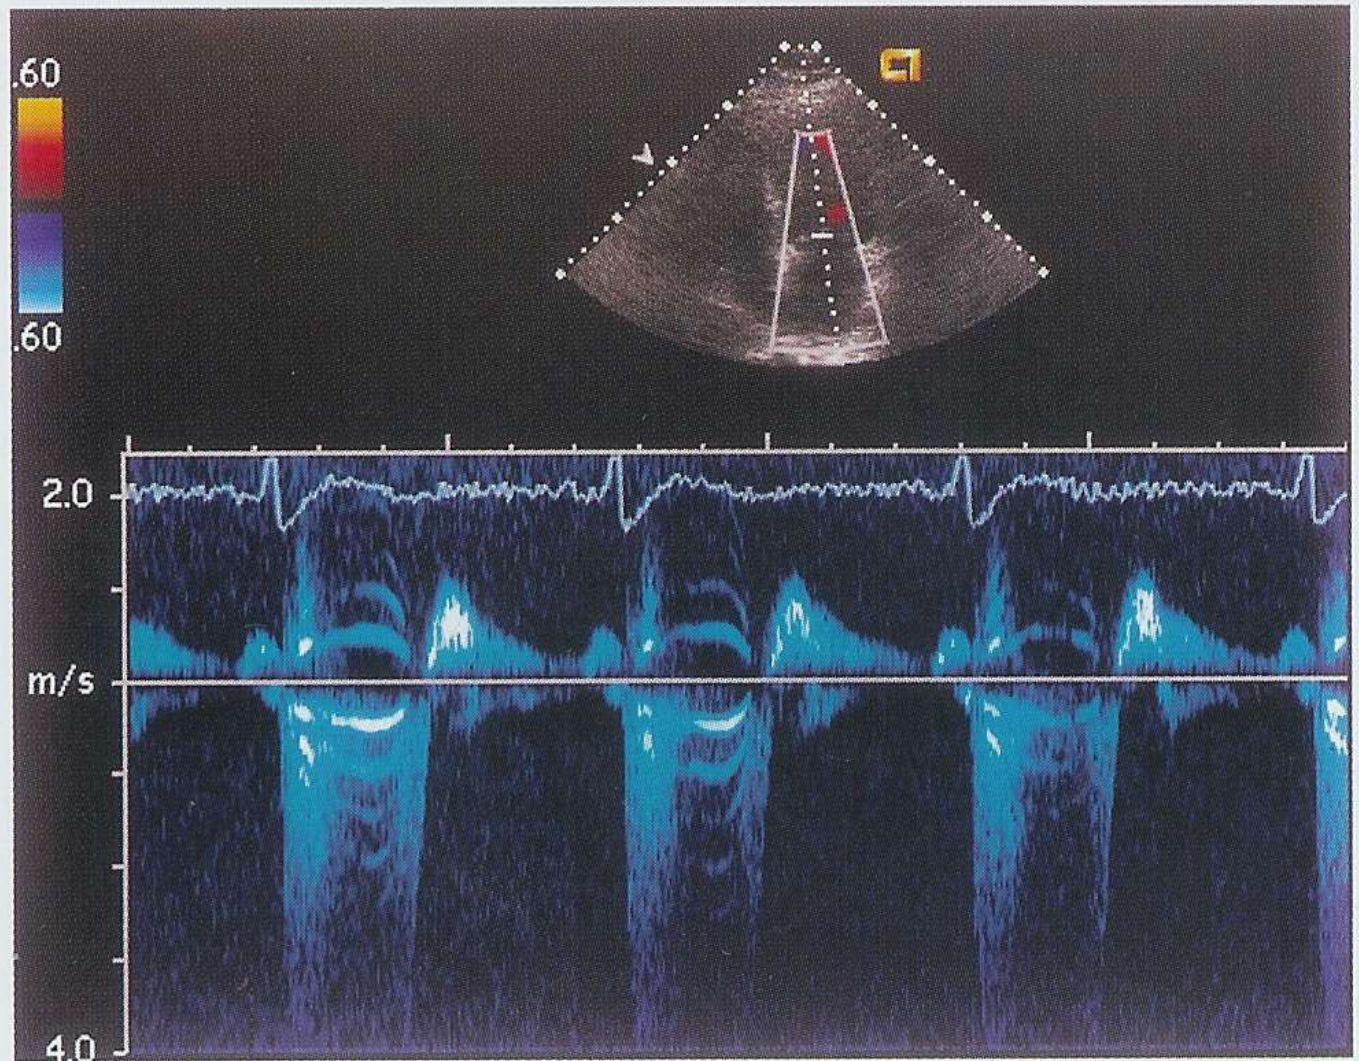
**FIGURE 14.44.** This particular signal may be recorded in the presence of a flail bioprosthetic valve. The unusual Doppler pattern may be the result of coarse fluttering of the flail leaflets.

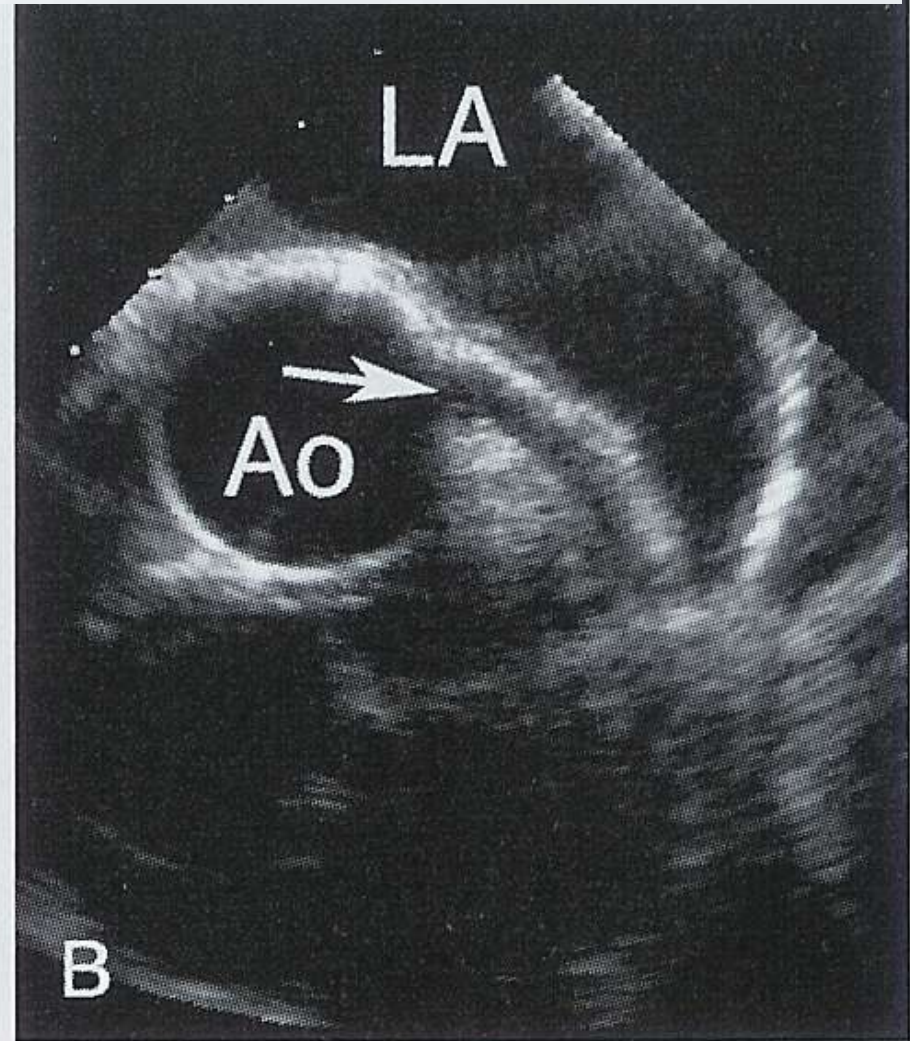
**FIGURE 14.57.** A Bentall repair of the aortic root is shown. **A:** The long-axis of the conduit is shown, and the highly echogenic walls of the prosthetic material are apparent. A disk-type mechanical prosthetic valve is shown. **B:** A short-axis view demonstrates the origin of the left coronary artery (*arrow*) just below the left atrial appendage. Ao, aorta; LA, left atrium.
